### AAMA 1503-09 THERMAL PERFORMANCE TEST REPORT

### CMI ARCHITECTURAL PRODUCTS, INC.

**SERIES/MODEL:** 6600 Curtain Wall **TYPE:** Glazed Wall Systems (Site-built)

Report Number: A2261.02-201-46

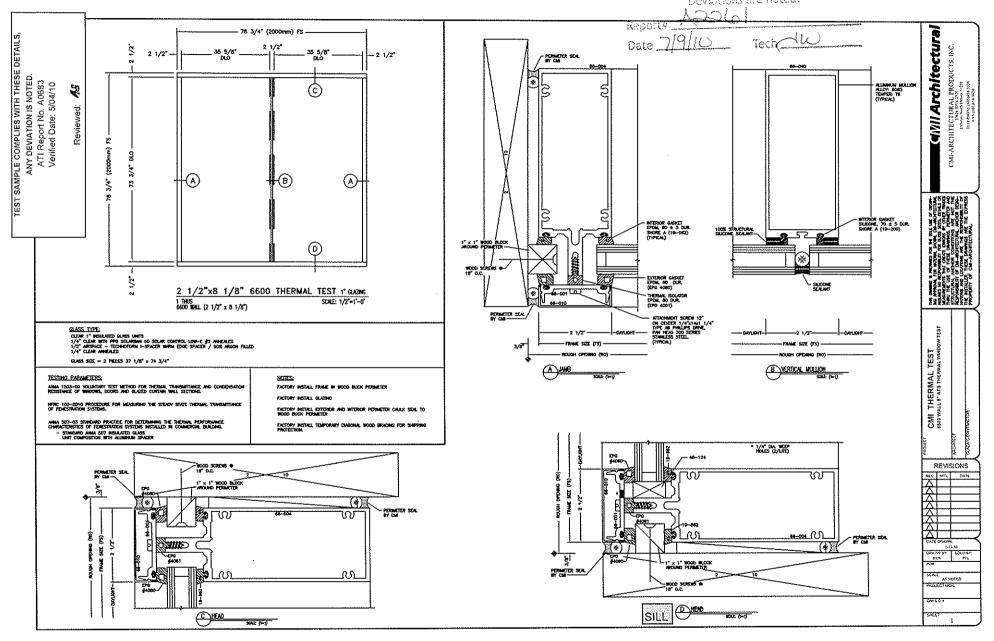
## **Appendix B: Drawings**

Test sample complies with these details.

Deviations are noted.
